RED CABIN CREEK CED RETROFIT

FEBRUARY 4, 2005

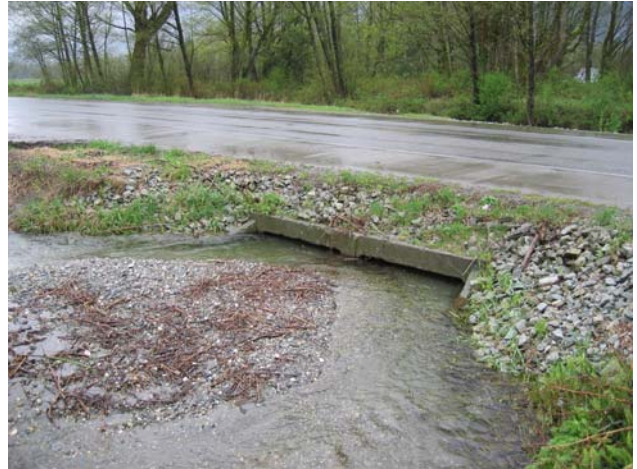
Figure 1. Red Cabin Creek CED site.
